MCCOY FEDERAL CREDIT UNION

SKIMMING DEVICES – HOW THEY LOOK

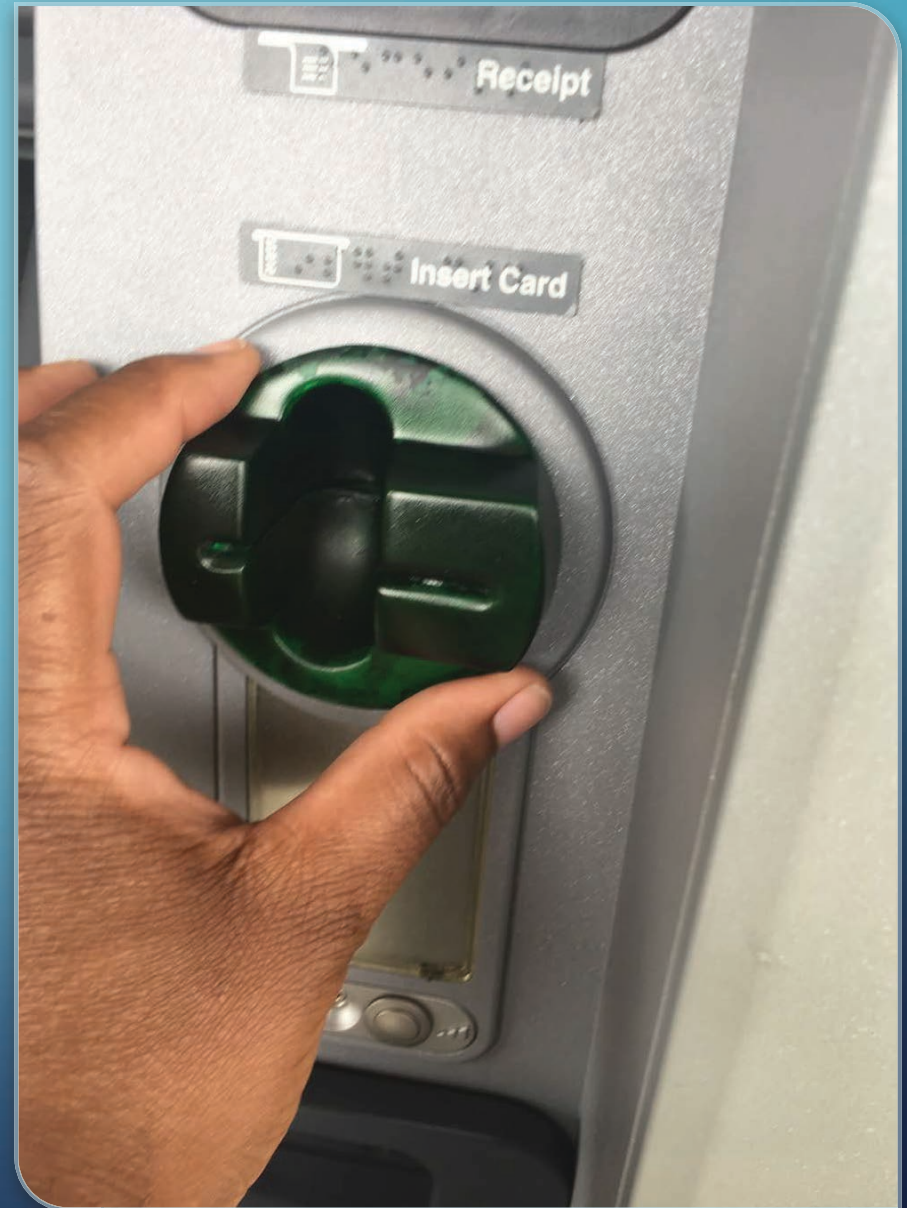
SKIMMING DEVICE

This is actual skimming device removed from the ATM card reader and this is how the skimming device looks when it is actually attached to the ATM. Notice that the ATM reader looks normal on visual inspection.

Without a physical inspection, it is difficult to see any problem with the card reader.

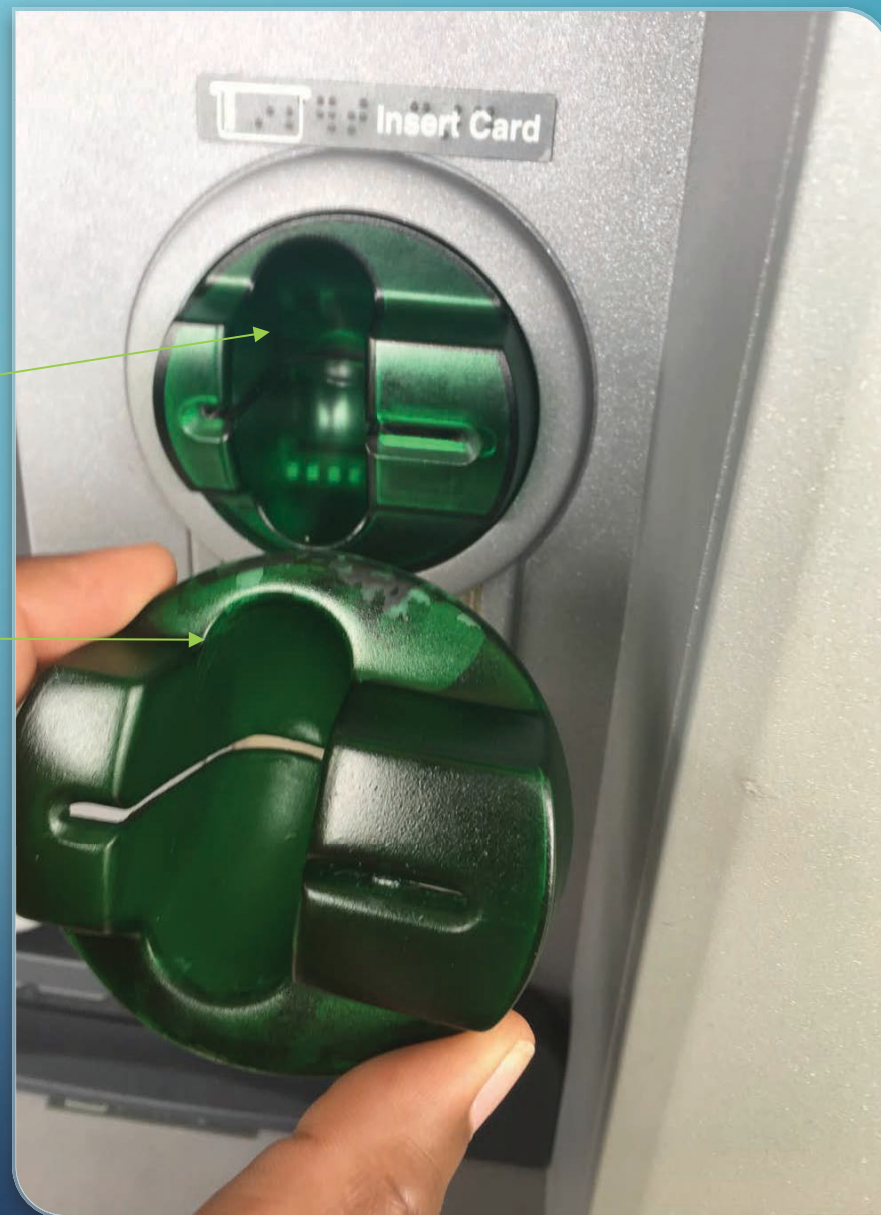
SKIMMING DEVICE

This skimming device removed from the ATM card reader looks identical when compared with the actual reader.

REAL

FAKE

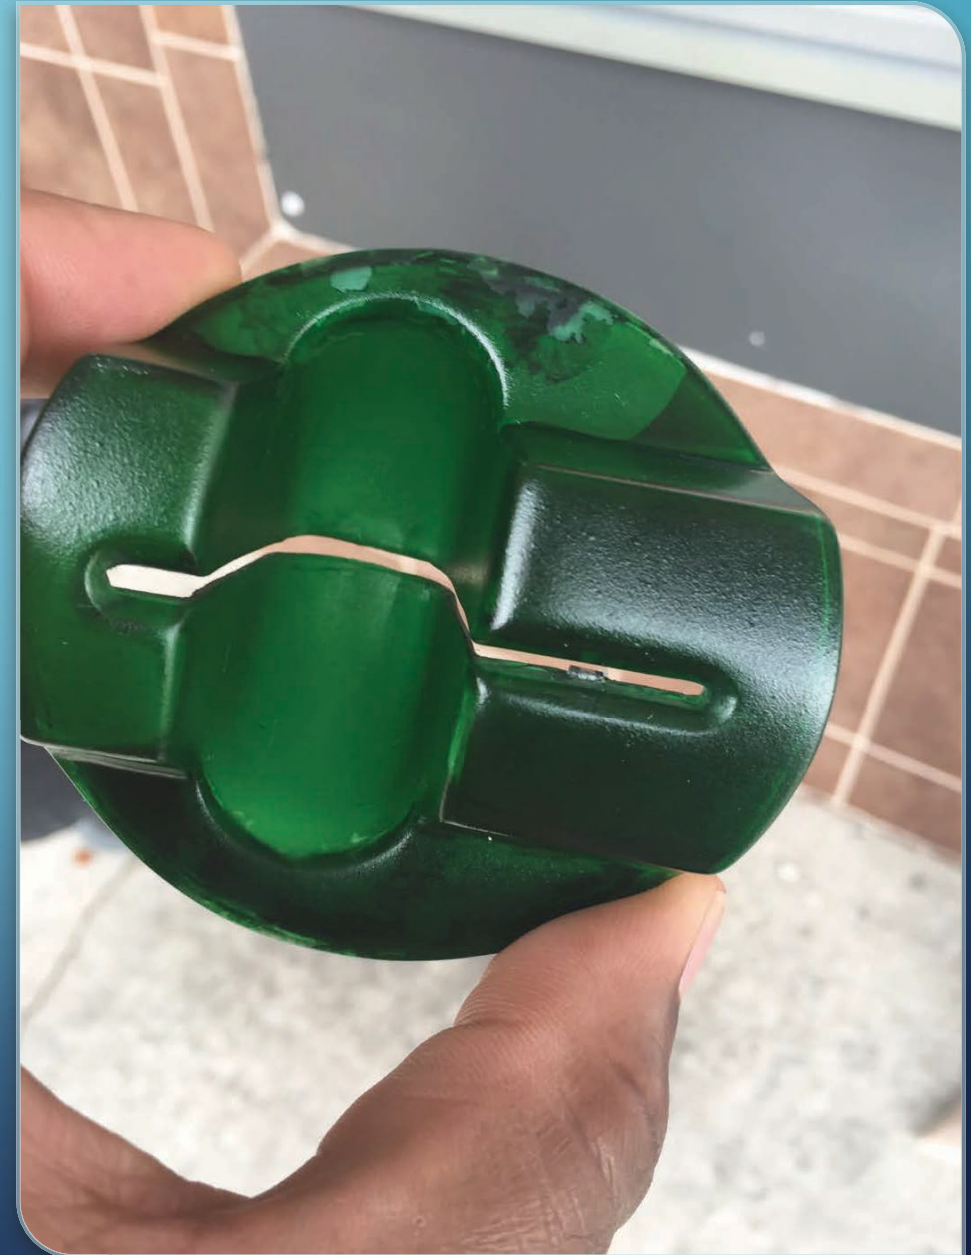
SKIMMING DEVICE

This is an actual skimming device removed from the ATM card reader that was placed on a financial institution's ATM. Except that it's detached, the reader looks fairly normal...

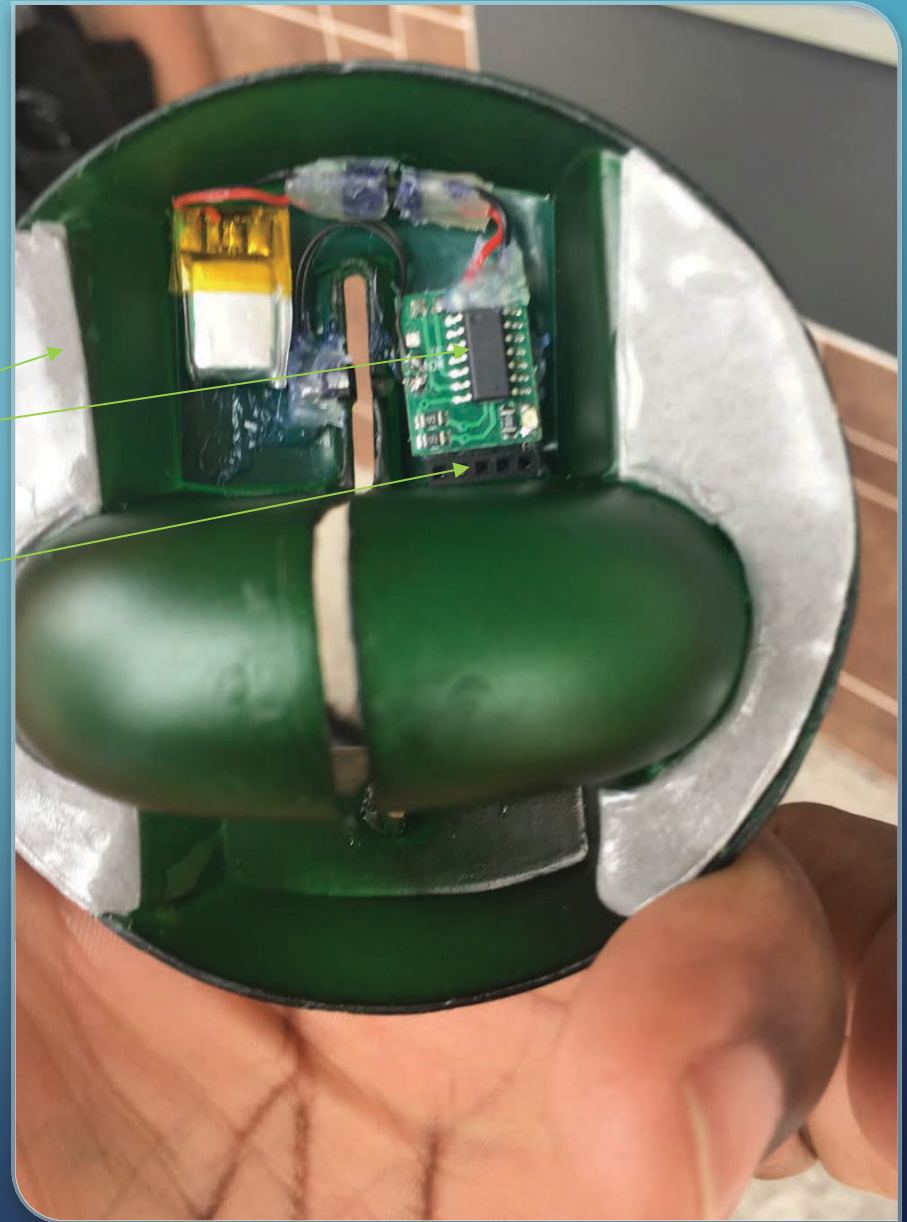
SKIMMING DEVICE

This is the same skimming device removed from the ATM card reader. But when you remove the skimming device and flip it over, you can see the white adhesive tape and the skimming hardware used to capture information from the magnetic strip. This particular device has a female connector for transferring card information and onto another device which can be used to create new cards.

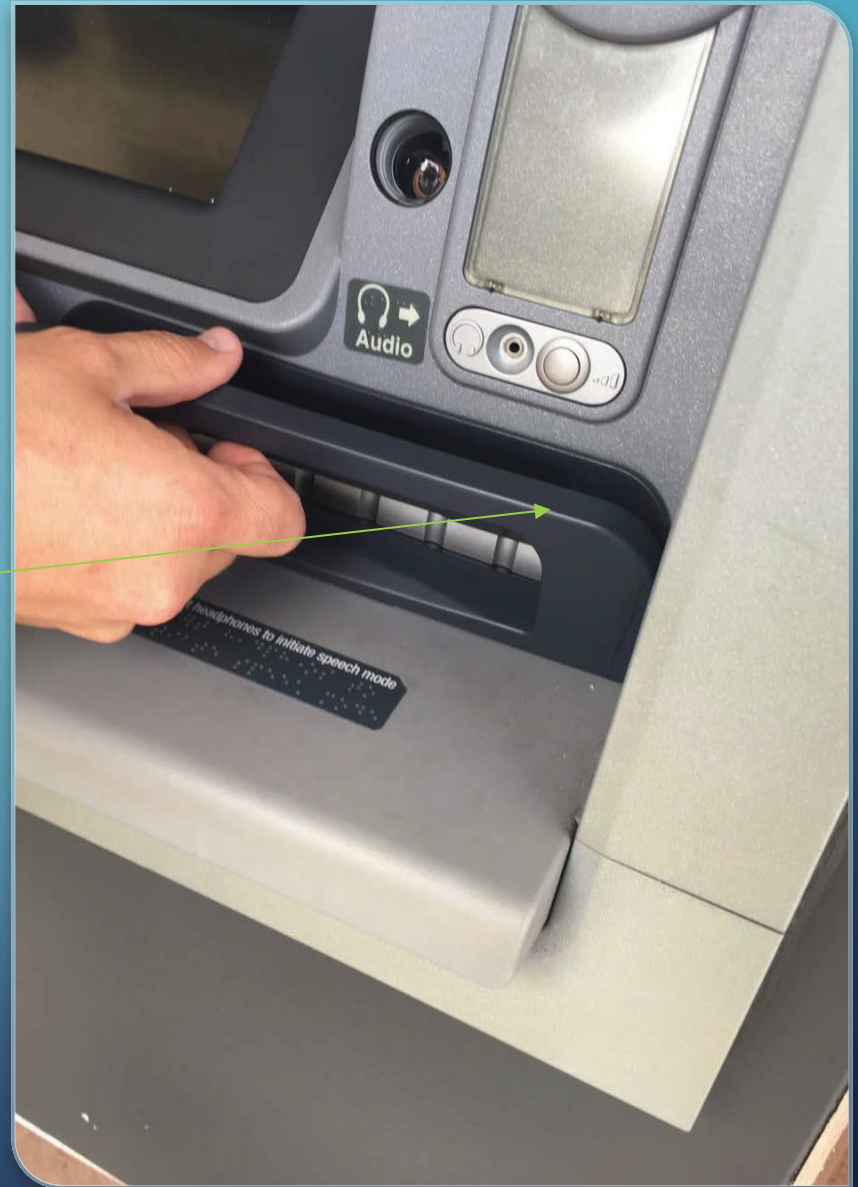
SKIMMING DEVICE

This skimming device removed from the ATM had two components. The second component of the skimming device was a camera used to capture members' PINs. The camera was hidden in the frame around the cash dispenser. Always tug on this frame to see if it comes loose.

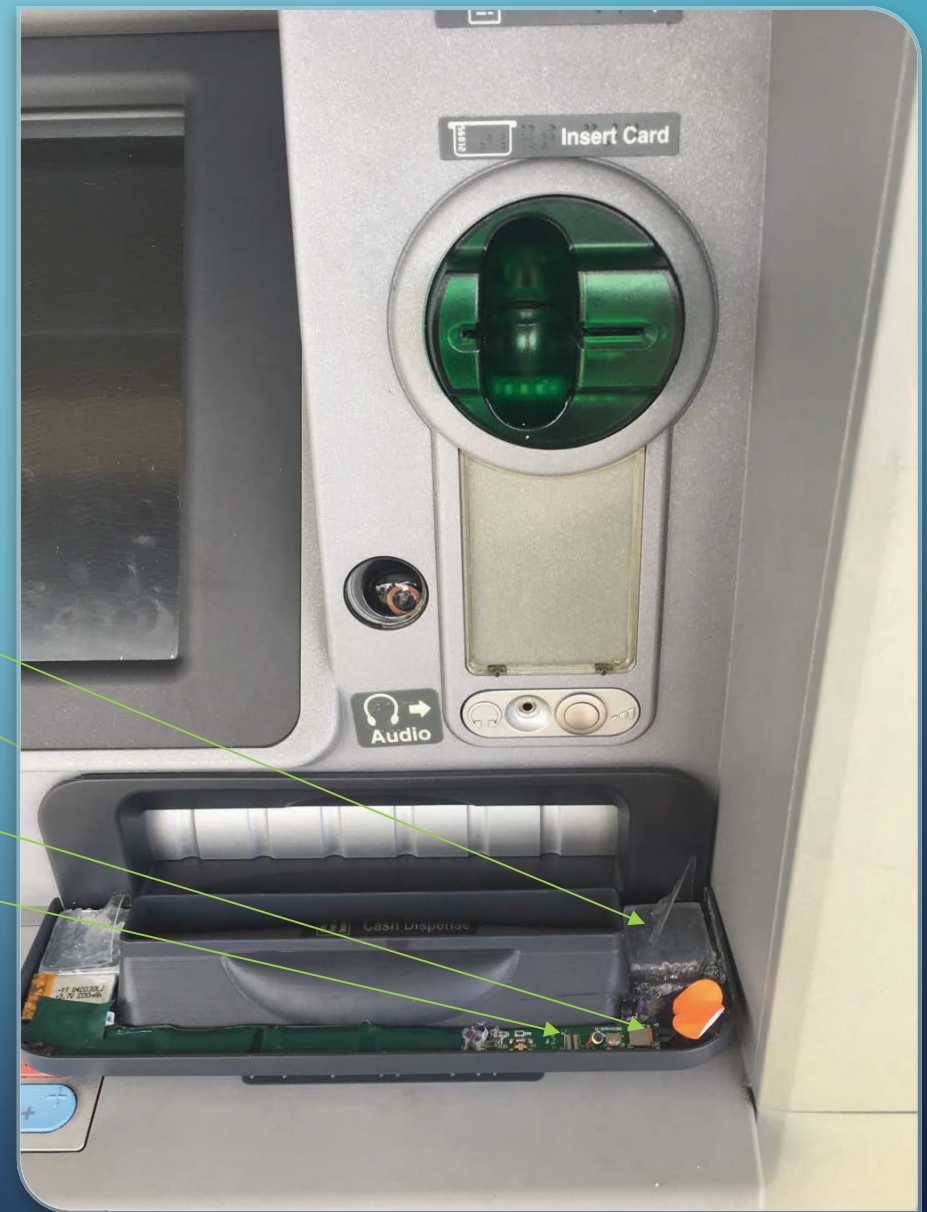
SKIMMING DEVICE

This is the backside of the skimming device removed from the ATM. The frame is attached with adhesive and is placed directly over the ATM cash dispenser frame.

The camera components are attached to the inside of the frame along with a chip to store information.

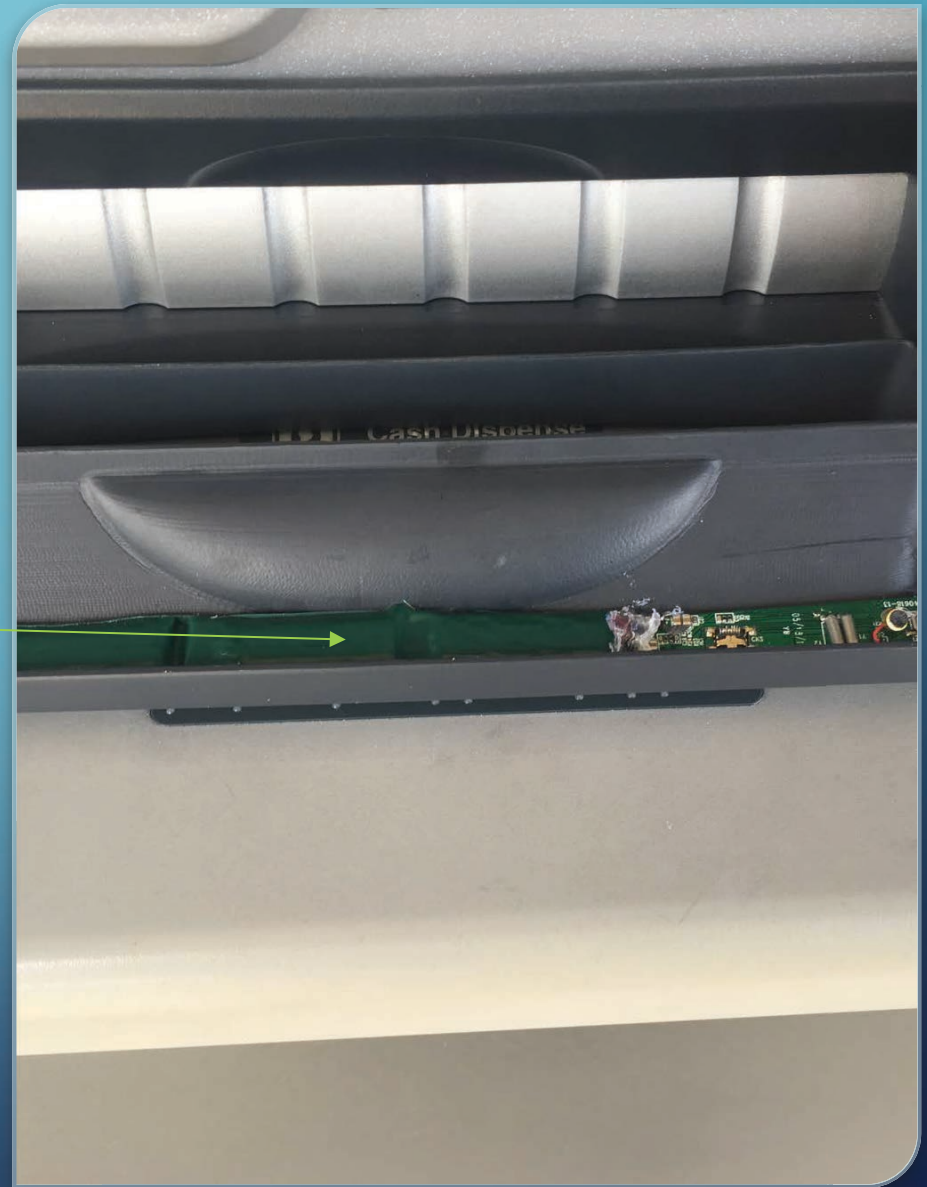
SKIMMING DEVICE

This is the skimming device removed from the ATM cash dispenser. The frame is attached with adhesive and is placed directly over the existing ATM cash dispenser frame.

The adhesive tape is also green.

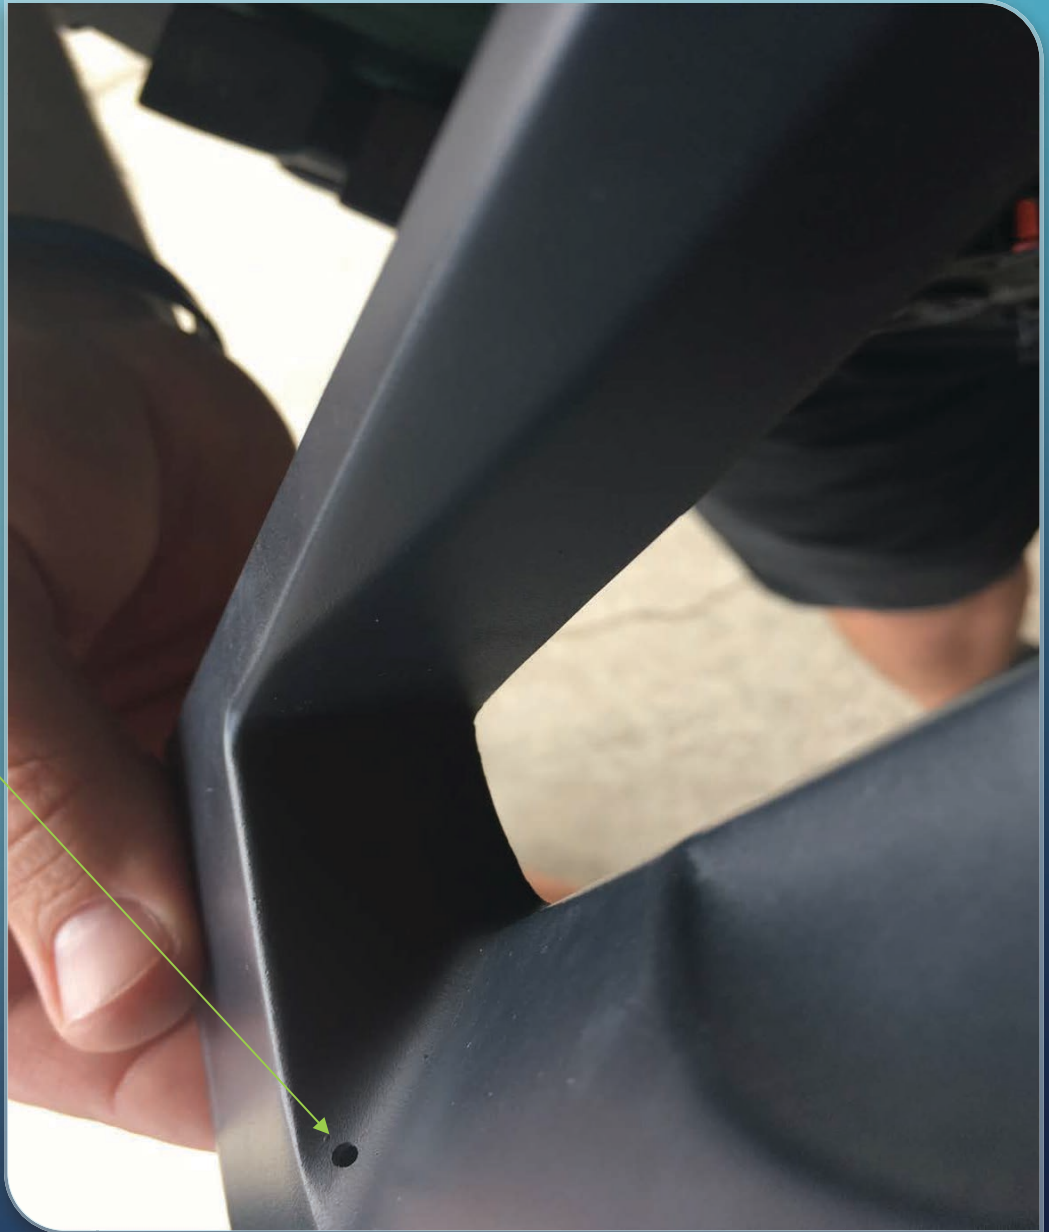
SKIMMING DEVICE

This is the skimming device removed from the ATM cash dispenser frame. Notice the small hole in the corner of the frame. This is unusual. The small hole provides a view for the camera lens.

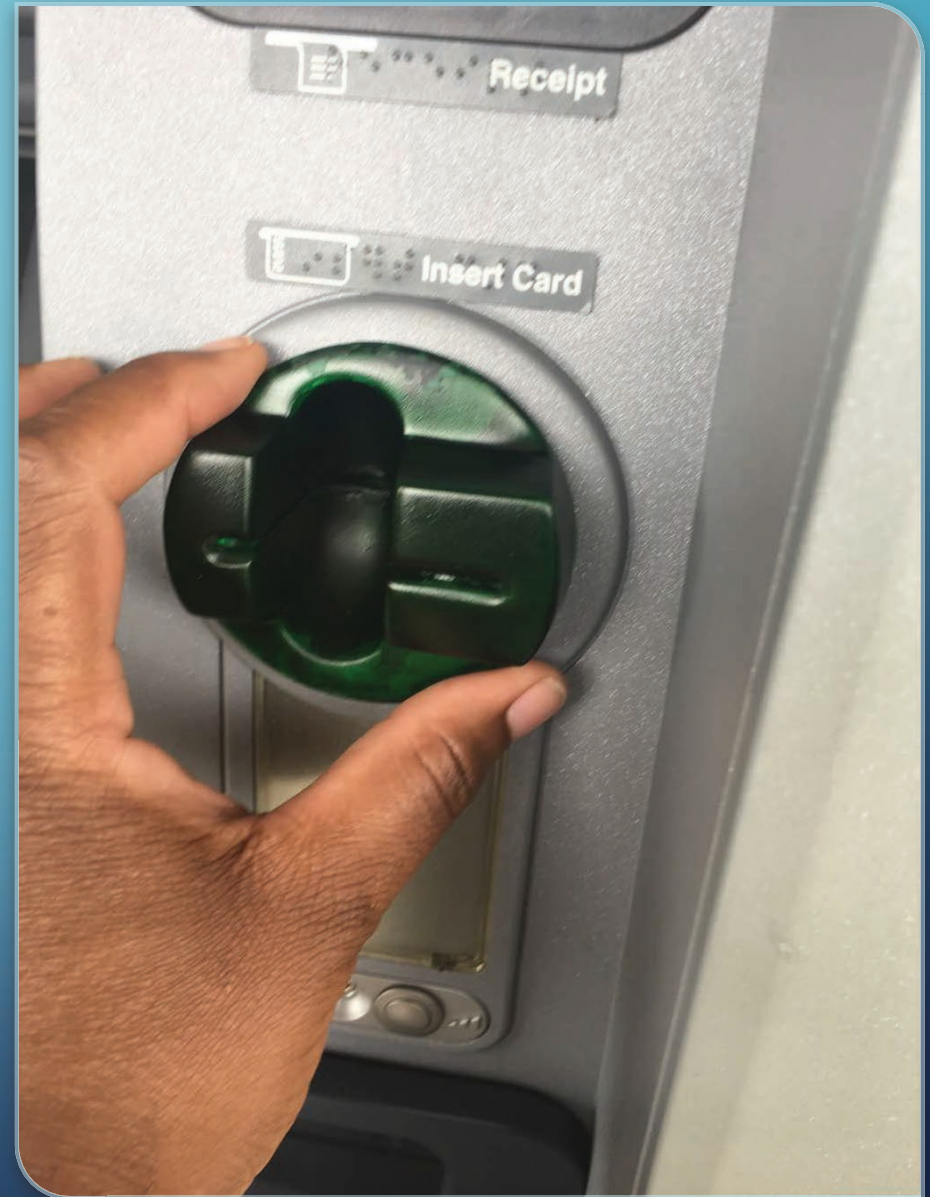
SKIMMING DEVICE

Remember: Just because it looks normal doesn't mean it is normal.

Always conduct a physical inspection by pulling or tugging on the card reader, the cash dispenser frame and the key pad.

Look for anything unusual such as holes, tape or wires.
